## Minerals Inspection Report

Mine Name: Pine Canyon Mine	Permit Number: M/045/0004	Mine Status: Active
Operator Name: Rio Tinto - Kennecott Utah Copper	Inspection Date: August 21, 2013	Permit Fees: Paid
Inspector(s): L Heppler, A Abate, T Nicolaysen	Inspection Time: 3:00 PM	Bond Amount: \$134,905
Attendee(s): T Lindsay, T Heaton	Weather: Sunny, Dry	Bond Escalation: 12/01/2016
Inspection Purpose: Routine annual inspection		Prior Inspection: May 10, 2012

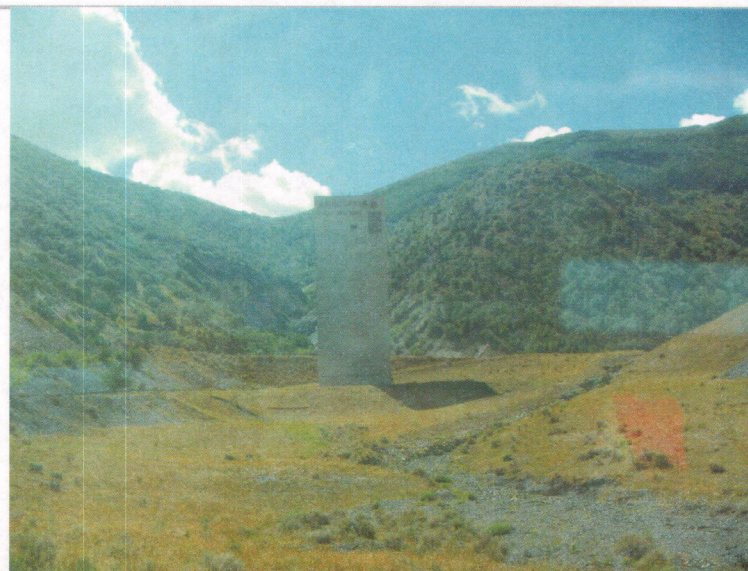
Shaft structure - looking east

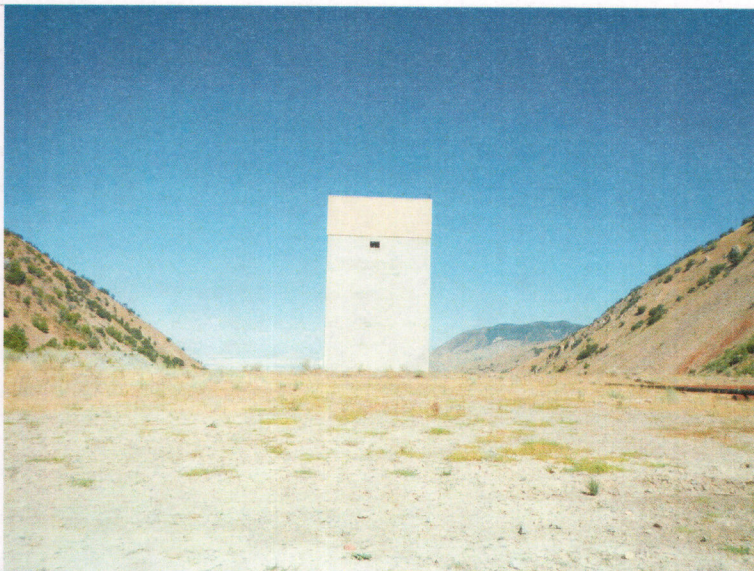
Top of shaft structure - looking west

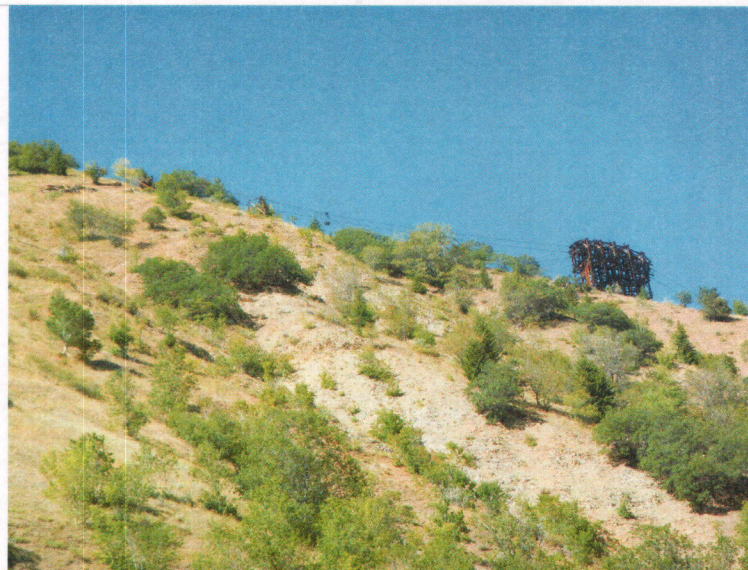
Old tram on skyline
